Bats in Churches: Objective Assessment of Associated Damage Mechanisms

This paper presents the preliminary results of research into the damage mechanisms involved when droppings and urine from insectivorous bats come into contact with a range of materials found within historic churches. It places the research in the wider context of conservation initiatives affecting both bats and historic church buildings in the UK.

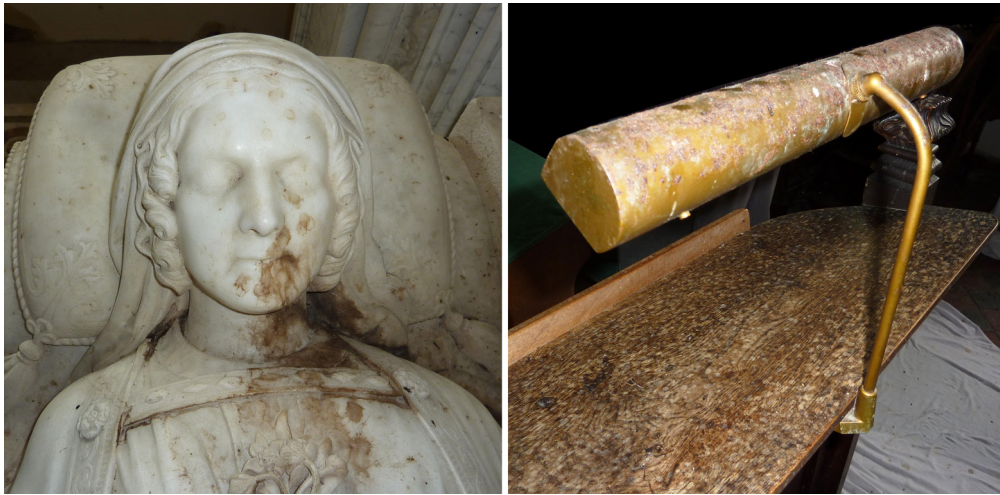
Fig. 1: Left, this marble funerary monument was situated under a bat roost, the staining has been caused by bat droppings and urine in combination. Right, this lectern shows the characteristic white spotting found on wooden surfaces caused by bat urine, the associated reading light is badly corroded.

For many years, bats have been thought to be responsible for some types of deterioration to the historic fabric of churches. However, for materials other than wall paintings, for which some research has been undertaken (Paine, 1991), our current understanding of bat related damage extends no further than being able to observe corrosion of metals, pitting of polished stone, white marks on varnished or polished wood surfaces and dark staining on pale coloured porous materials such as alabaster (**Fig. 1**). We do not

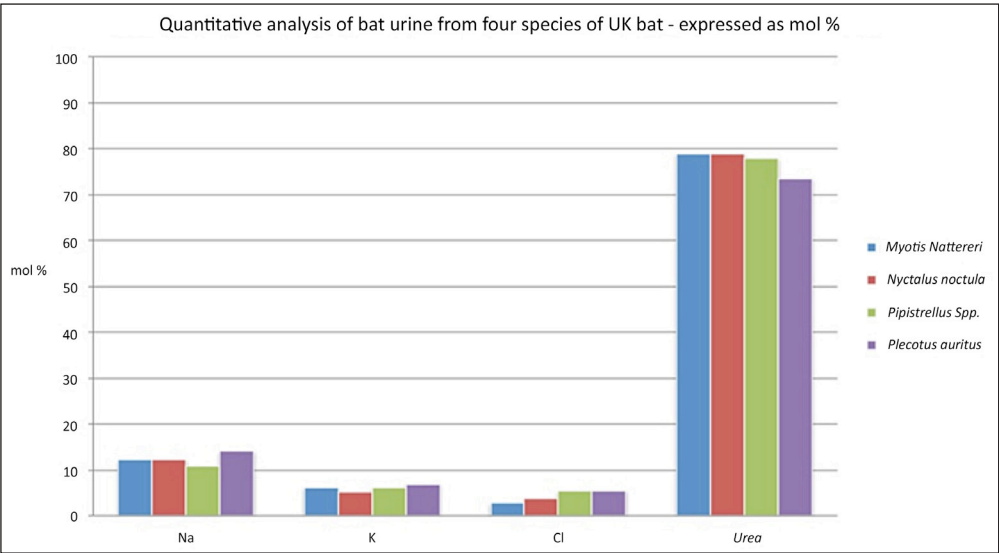
Fig. 2: Graph showing quantitative analysis of urine from four different species of bat converted to relative molar percentages for each species.

species examined. However, by expressing the concentration of the solute in each sample as molar percentages (i.e. expressing the different analytes as quantities relative to each other) (**Fig. 2**) it can be seen that the components of the bat urine analysed show a good degree of consistency across the four species, with little to no variance beyond the calculated standard deviation. What this means, is that urine composition is broadly consistent across all four species, yet the concentration of the urine is not.

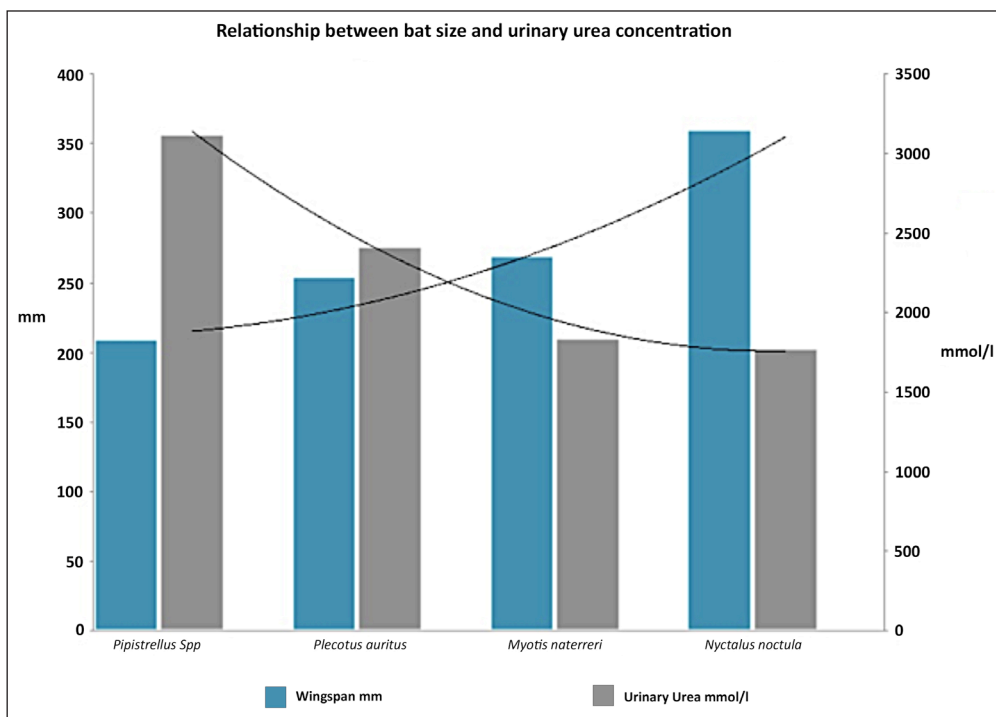
Fig. 3: Graph showing the inversely proportional relationship between bat size (represented by wingspan in mm) and urea concentration in mmol/l. To further highlight the relationship, polynomial trend lines are shown for both wingspan and urinary urea.

proportional to the size of the bat, with larger bats producing more dilute urine. Fig. 3 shows the relationship between bat size (represented by wingspan) and urea concentration - the relationship between the two parameters can clearly be seen. If the solutes detected are found to play a significant role in deterioration mechanisms, then clearly their relative abundance in the urine of different species of bat will be a factor affecting the levels of deterioration that might be expected from roosts of different species.

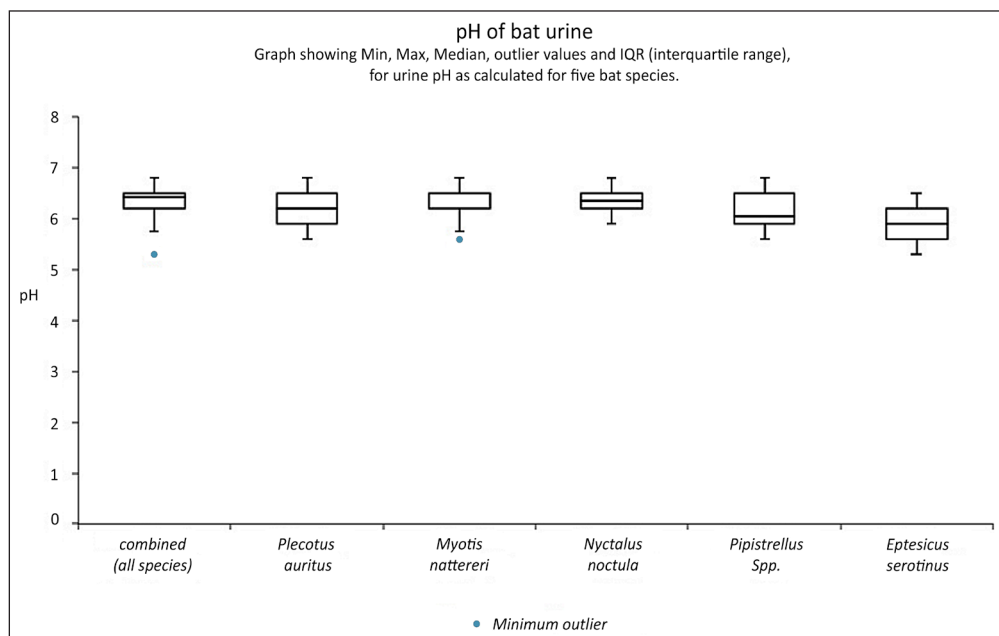
Fig. 4: Median Dq plot showing urine pH ranges obtained for five UK bat species. The graph is a “box and whisker” plot. The “whiskers” show the minimum and maximum pH values recorded for each species, the interquartile range (Q_3 - Q_1) shows the distribution of the middle 50% of the data points and is represented by the “box”, the median value shown by the horizontal line appearing inside.

four species listed above). A combined total of 73 individual pH readings were recorded (Fig. 4). pH measurement was conducted on my behalf by licensed bat workers, measurements were taken from fresh urine collected as before from captive bats.

As can be seen, pH ranges for all species tested are broadly similar with a total range for all readings between pH 5.3 - 6.8. Technically speaking all these values fall within a pH range that would be described as acidic, however to provide some context, bottled drinking water sold in the U.K. has a pH that ranges from 4.2 – 8.7 depending on source (Bucksc, 2005) and de-ionised water used in conservation laboratories commonly has a pH of 5.5. Therefore, while the pH of bat urine is acidic, it is only mildly so. Although it should be noted that long term exposure to mildly acidic solutions can be problematic for some materials (for example calcareous stone), my findings do not

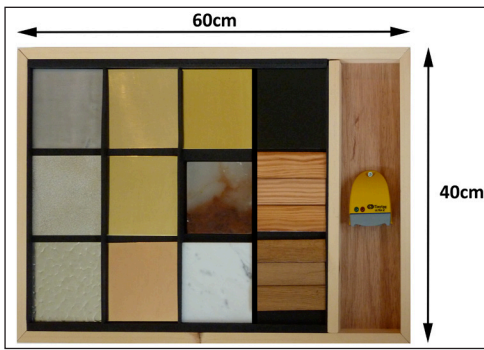
Fig. 5: Sample board prior to deployment and positioning of protective elements to partly cover the test samples, and showing the data logger.

The sample boards consisted of wooden trays 60cm x 40cm holding prepared samples of 10cm x 10cm each (Fig. 5). The design allowed for samples to be partly covered so that a section of their surface was protected thus providing a control specific to each individual test material. Each tray carried a data logger used to record relative humidity (RH) and temperature for the duration of the exposure period. This was considered important as temperature and RH would likely play a role in corrosion cycles, rates of reaction and the effect of salt crystallisation within porous substrates.

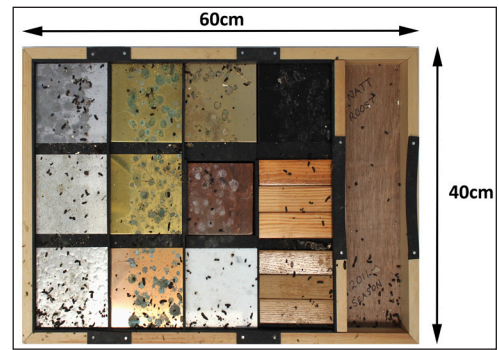
Fig. 6: Phase 1 Sample board after retrieval, the effect of bat droppings and urine on the test materials is readily apparent.

This aspect of the work represents a two-year cycle of experimental work, and has generated a dataset of 84 different sample surfaces on which subsequent analysis can now take place. While a full analysis of the test samples has yet to be undertaken, there are some interesting preliminary results. Of foremost importance is the fact that the deterioration seen on the test samples is directly comparable to that observed *in situ*, for example in the case study churches, with corrosion of metal surfaces, staining of porous materials, and the distinctive white spotting resulting from urine deposition on organic coatings (such as polishes) all seen on the test samples (Fig. 6). From initial observations it can also be seen that

investigation should focus not only on the effects of urine and droppings individually, but also on their effects in combination as it appears that this can affect both the type of corrosion seen on metal surfaces and the staining observed on porous materials.
